**GEOTECHNICAL AND
ENVIRONMENTAL CONSULTATION
GGBS MANUFACTURING FACILITY
Vallejo, California**

**Ecocem Materials
Dublin, Ireland**

**20 February 2013
Project 731608801**

Subject: Geotechnical and Environmental Consultation
GGBS Manufacturing Facility
Vallejo, California

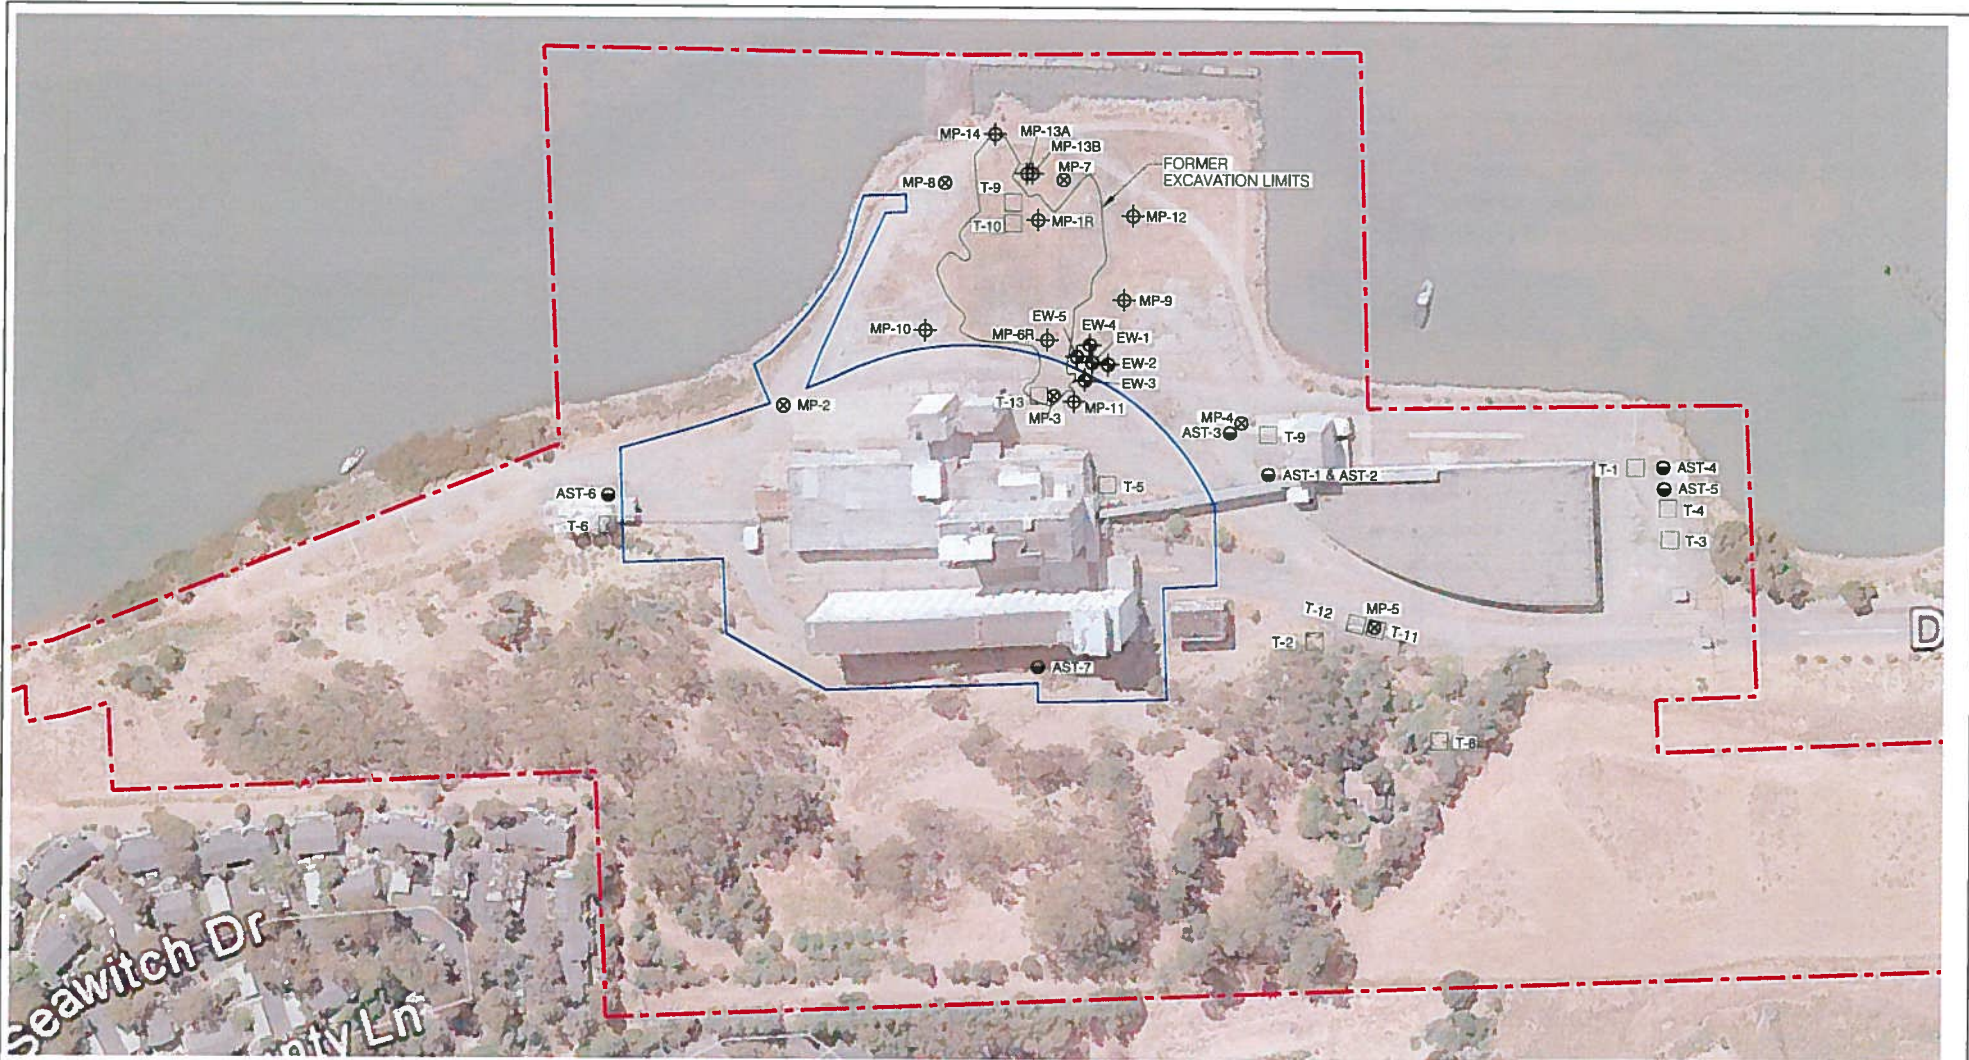
From approximately 1869 until 2004, the site was used as a grain mill and processing plant. Site operations included the use and storage of petroleum hydrocarbons that were used for fueling vehicles and for heating facility operations. Petroleum hydrocarbon products were stored in a combination of above ground storage tanks (ASTs) and underground storage tanks (USTs). A total of seven former ASTs and 13 former USTs (T-1 through T-13) were identified as being used during the facility operations. Operations historically conducted on-site included the cleaning, processing, bleaching, and packaging of flour and other General Mills products. The locations of the former ASTs and USTs are shown on Figure 2.

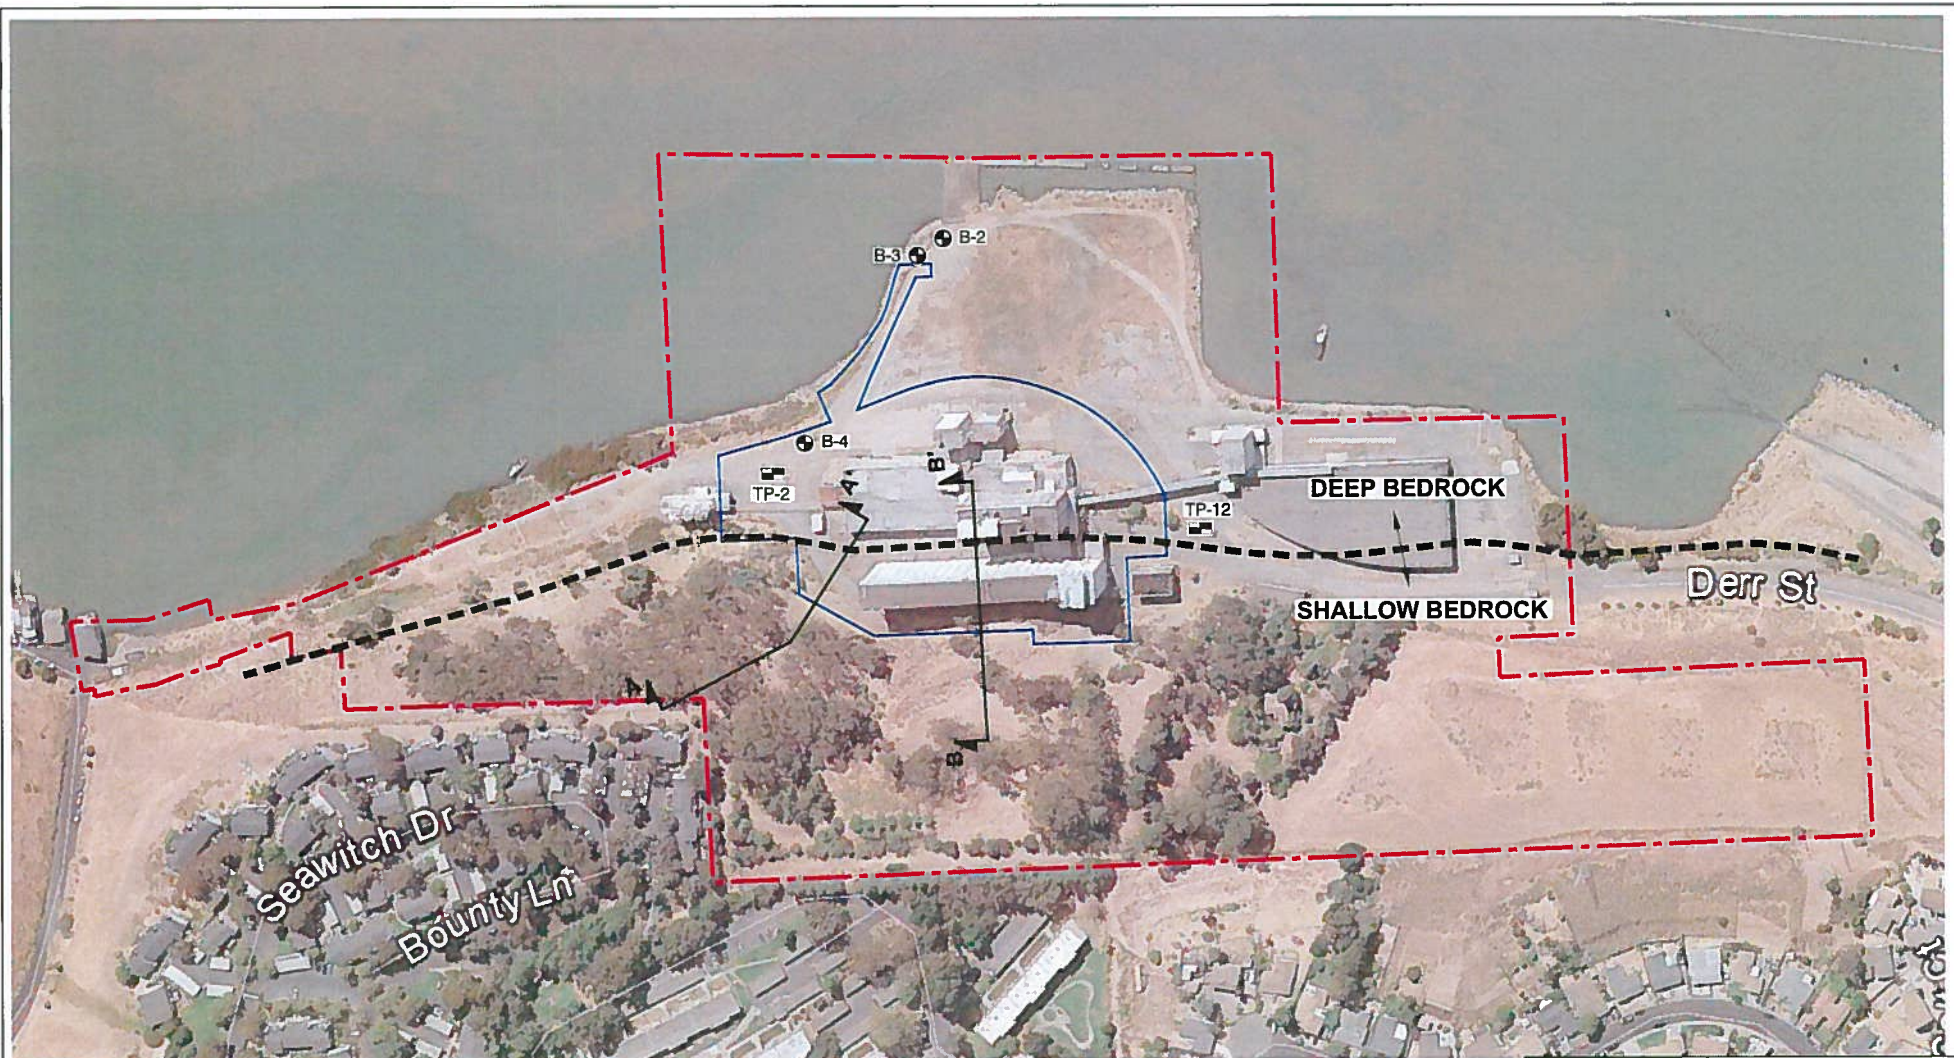
GGBS MANUFACTURING FACILITY Vallejo, California		
SITE PLAN SHOWING GEOTECHNICAL INFORMATION		
Date 02/15/13	Project No. 731608801	Figure 3
Treadwell & Rollo <small>A LANGAN COMPANY</small>

The western portion of the site appears to be blanketed by clayey fill. The fill is either underlain by directly by bedrock or soft clay locally referred to as Bay Mud, which overlies bedrock. The contact between bedrock (or shallow bedrock) and fill (deep bedrock) as mapped by Engeo is approximately as shown on Figure 3.

We performed engineering analyses to evaluate the stability of the descending slopes on the northeast and east sides of the site, along the alignments of profiles A-A' and B-B' as shown on Figure 3. These profiles were generated based on subsurface and topographic information provided in the Engeo report dated 27 June 2008. They were selected to represent the most critical slopes from a topographic standpoint that may impact the site. We concluded that the critical slope condition appears to be in the southeast corner of the site, near Mr. Durnal's profile D-D'. We performed an analysis on a profile of the slope at this critical location (our A-A'), and a second analysis on a profile just southwest of Mr. Durnal's B-B' profile (our B-B').

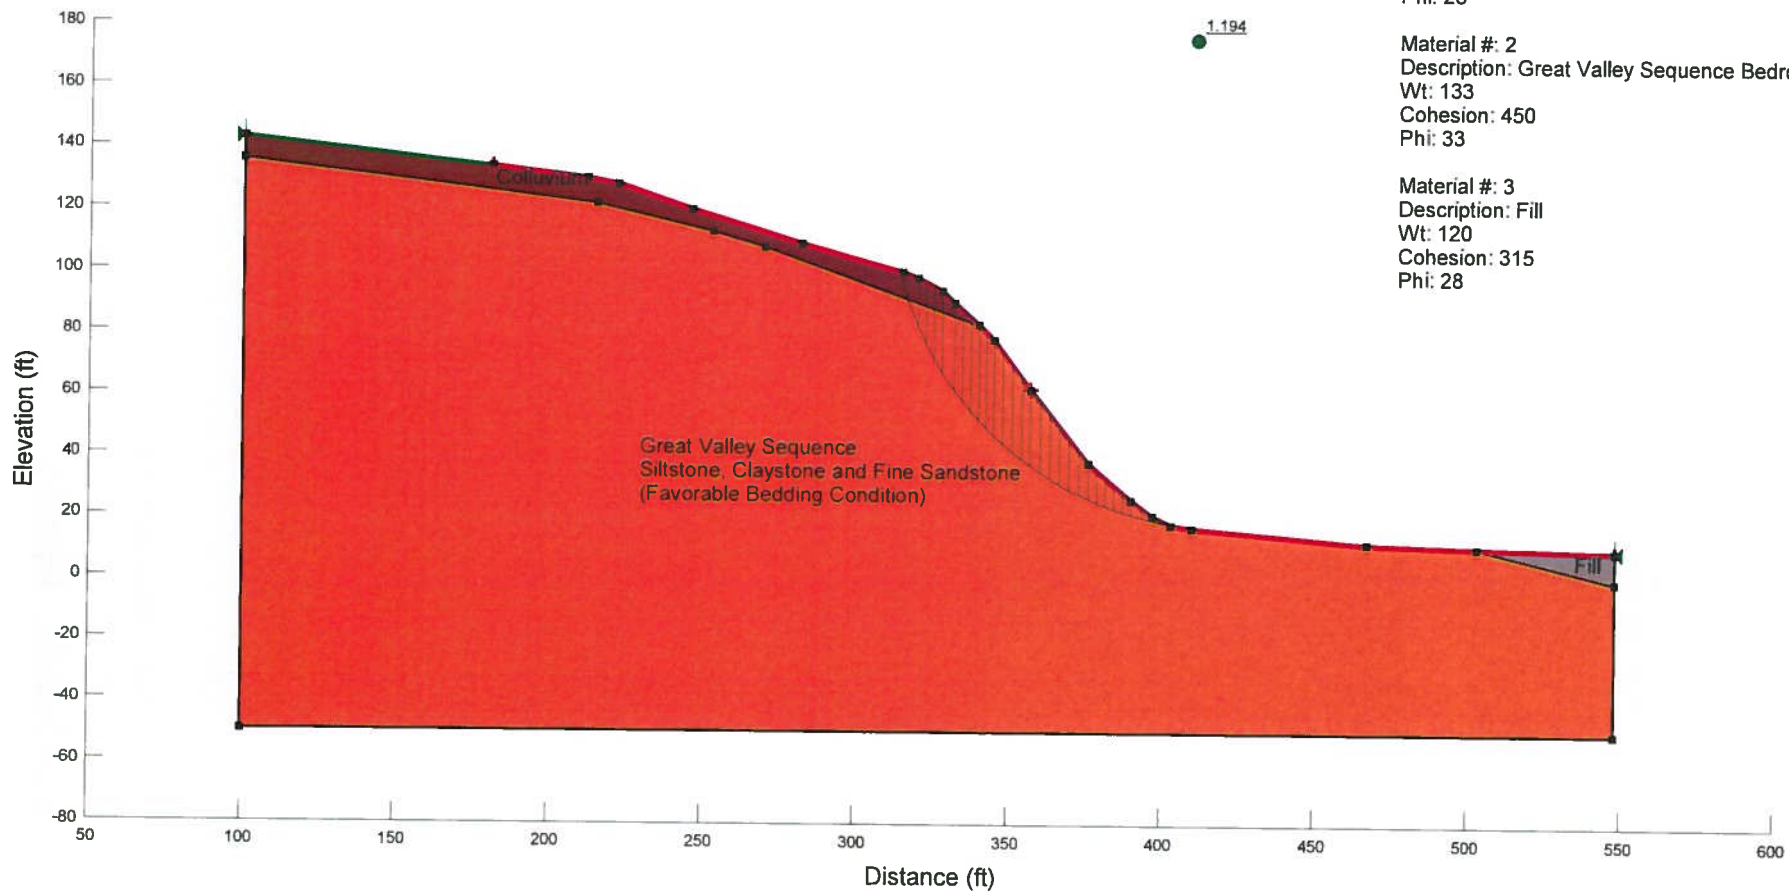
Slope Stability Analysis A-A'
Static Run

Results of our analyses indicate the static factors of safety for the existing slopes vary from about 1.2 to 2.1. The location of the critical slope failure surfaces for each of the profiles evaluated are provided in Figures 6 and 7.

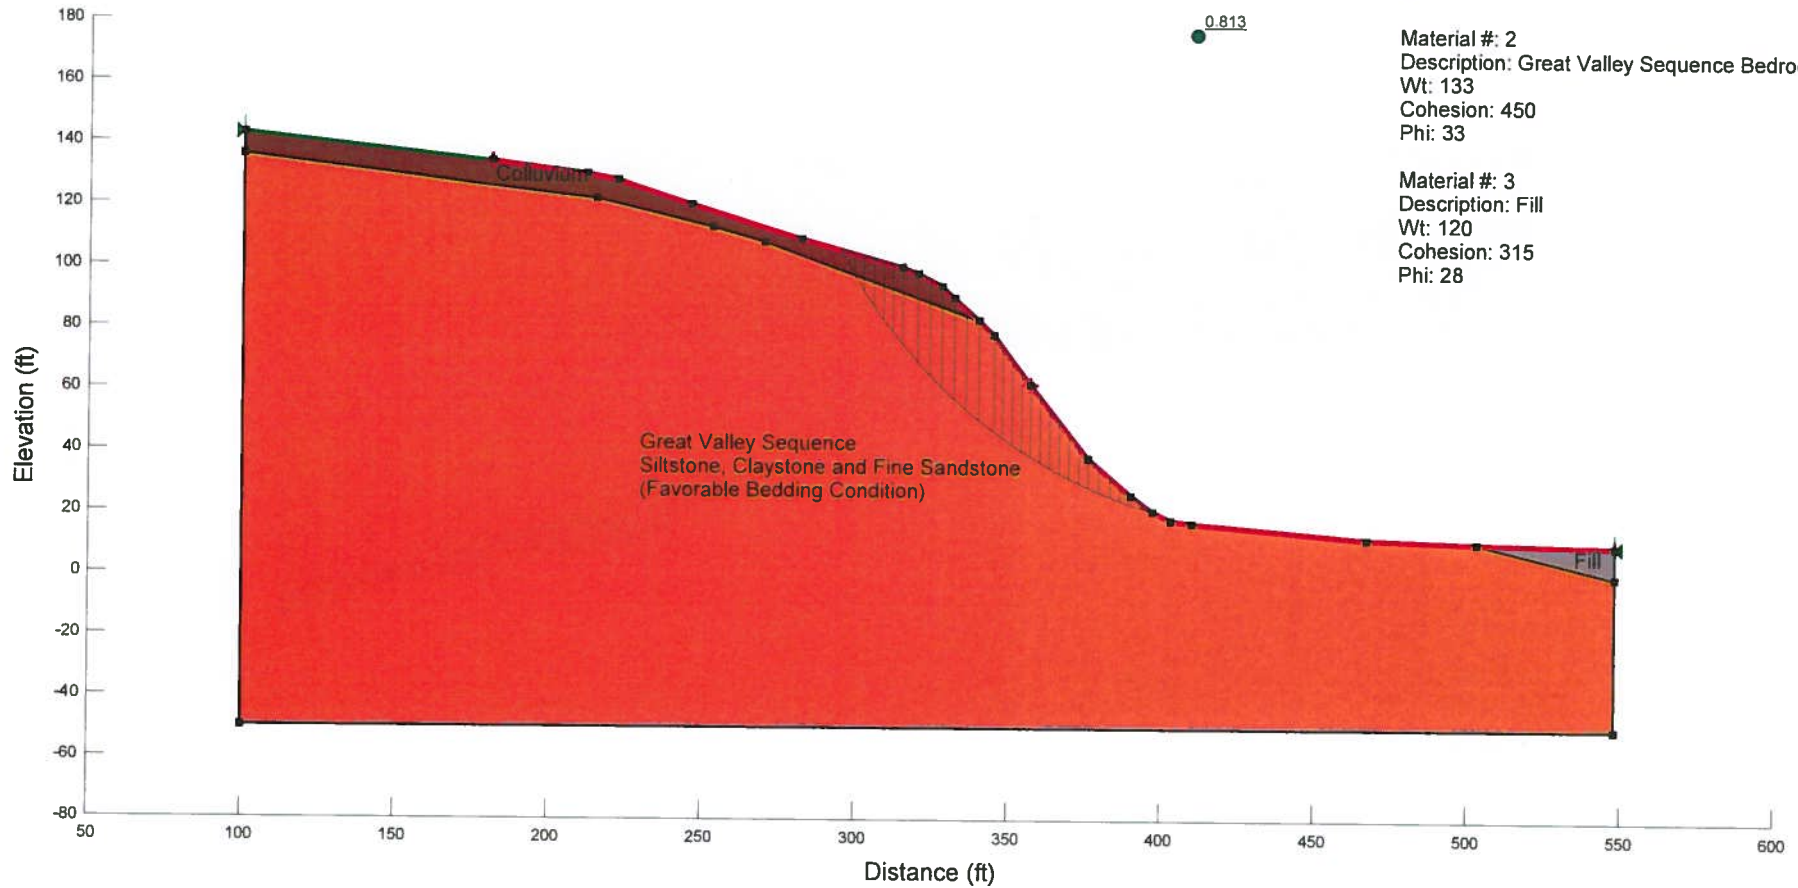
A-A' PSEUDO-STATIC ANALYSIS

The pseudo-static analysis for profile A-A' resulted in a factor of safety of less than 1.0. Figure 8 presents the critical failure plane for section A-A'. By modifying the horizontal seismic coefficient within each stability run (using the SLOPE/W program) we obtained the magnitude of the horizontal seismic coefficient that corresponds to a seismic factor of safety equal to 1.0 for this profile; the results of the yield analysis for section A-A' are presented on Figure 9. The corresponding horizontal seismic coefficient is referred to as the yield acceleration for that profile.
