COMPREHENSIVE LONG-TERM ENVIRONMENTAL ACTION NAVY (CLEAN II)

Northern and Central California, Nevada, and Utah

**FINAL
FINDING OF SUITABILITY TO TRANSFER
PARCEL XV-A
MARE ISLAND
VALLEJO, CALIFORNIA**

January 4, 2001

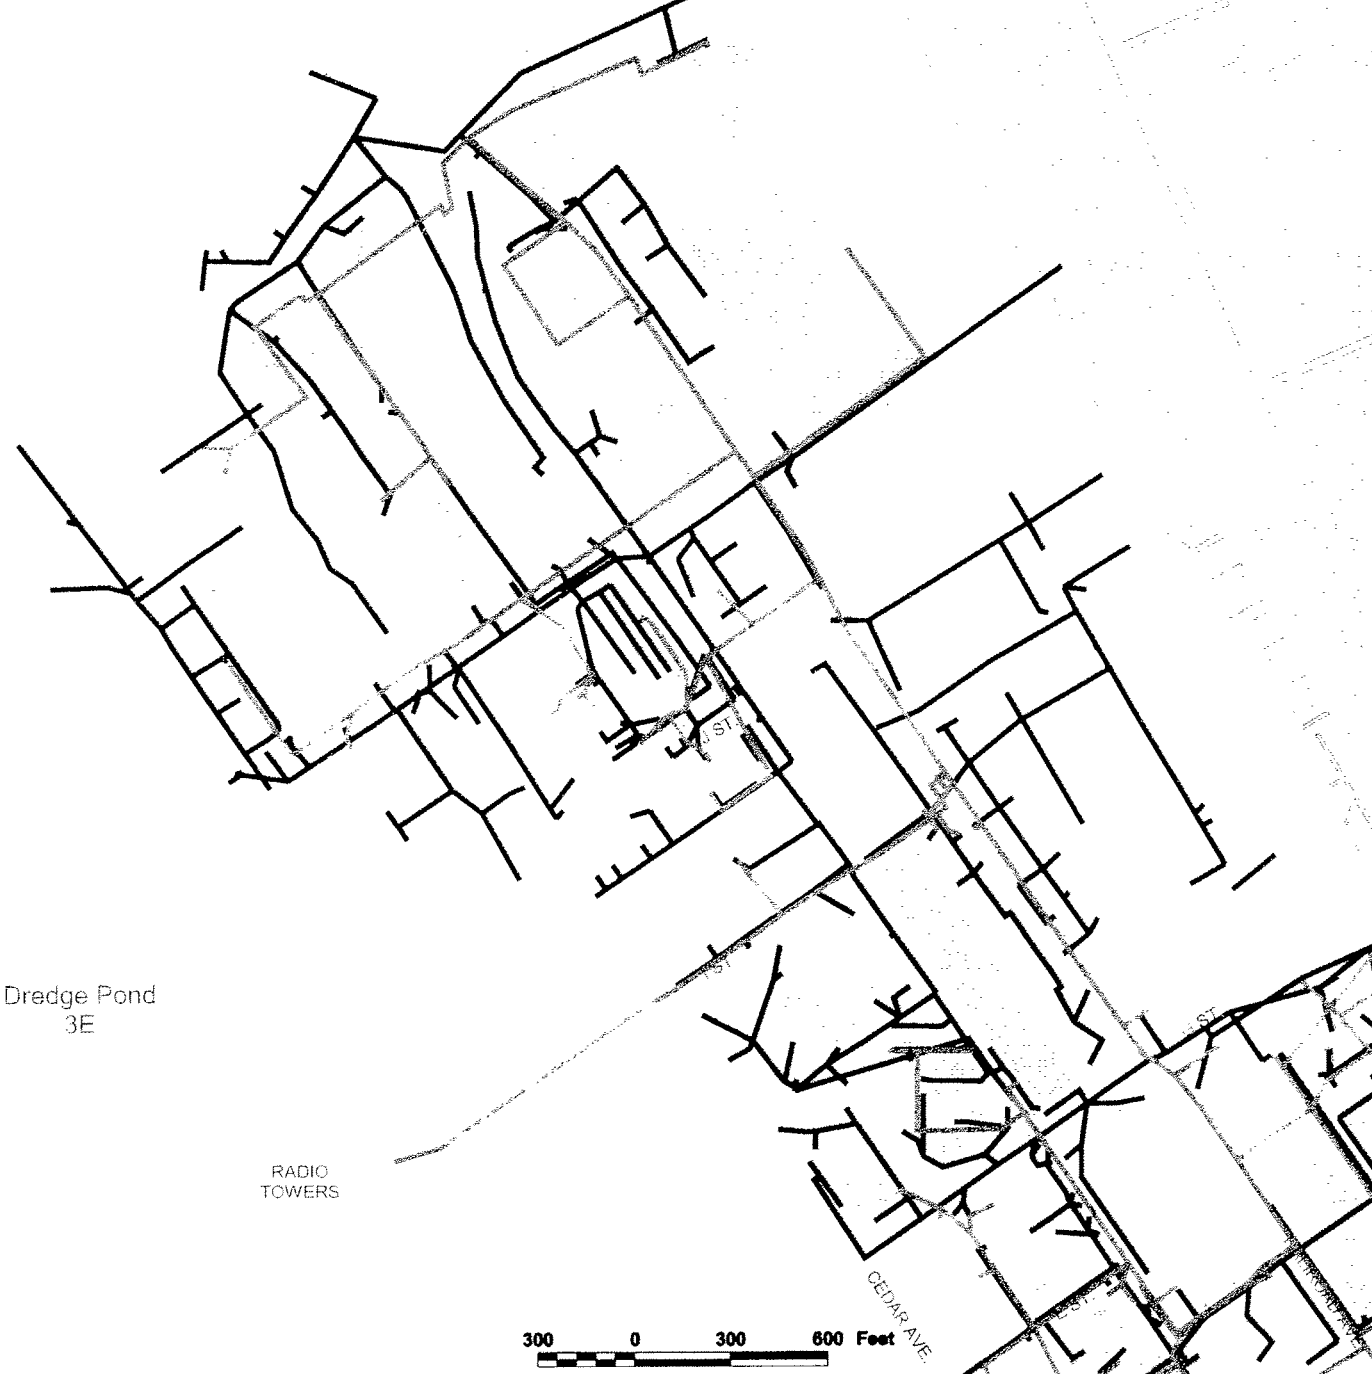
SANITARY SEWER PIPELINES
STORM SEWER LINES
SHARED STORM/SANITARY LINES
PARCEL XV-A
